# HOME INSPECTION REPORT

**ADDRESS:** 6316 NW Sample Street  
Sample, Fl. 32605

**DATE:** May 11, 2004

**ADVANCED HOME INSPECTIONS**

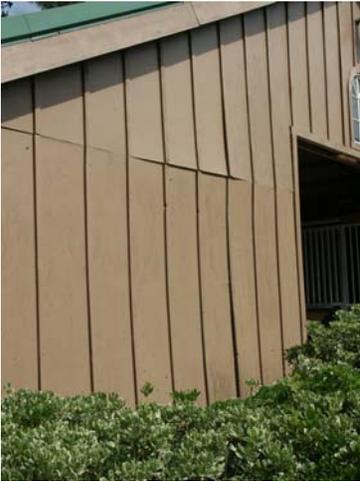
There is siding at east end of the barn that is loose, split or otherwise damaged and needs to be repaired by a competent carpenter to ensure that the exterior envelope of the home remains weather tight.

Loose siding (East side of barn)

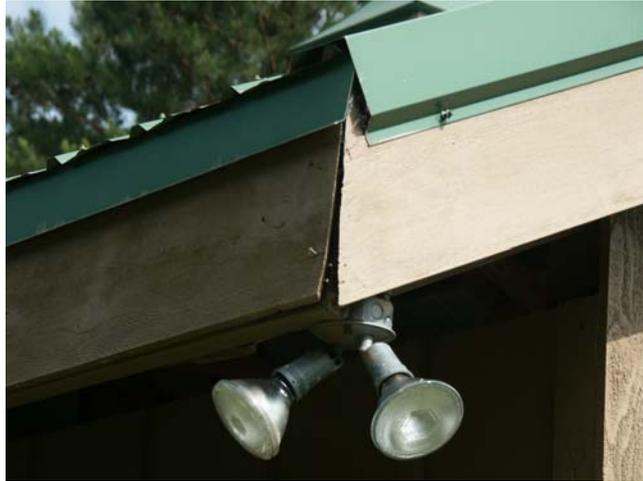
There are some fascias boards that are loose or have detached from the home. We recommend immediate repair by a competent carpenter.

Loose fascia board (SE corner of barn)

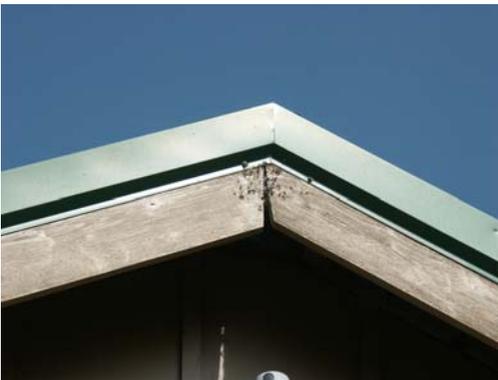
There is loose, damaged or missing trim at several areas of the barn. (see photos) Besides being unsightly, loose/missing trim can result in water penetration that leads to rot and insect infestation. A competent carpenter needs to make repairs.

Split fascia at east barn ridge

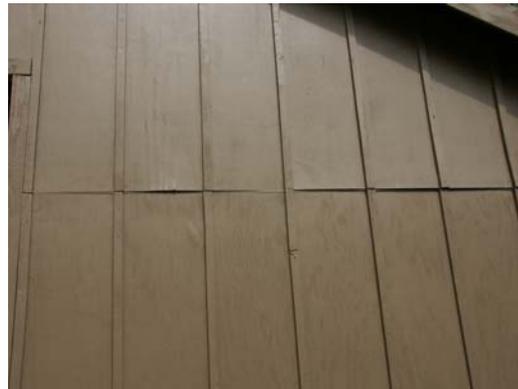
Siding at barn

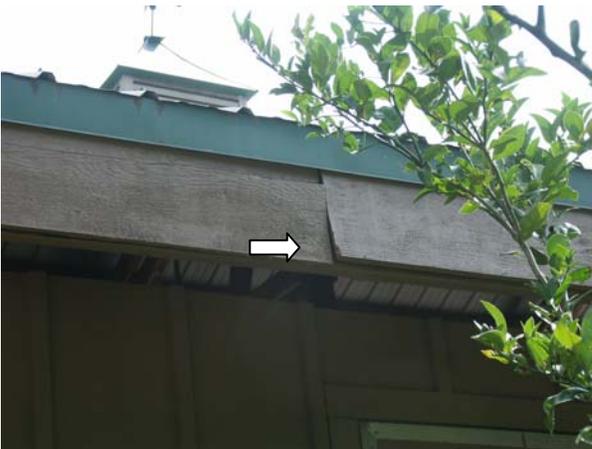
Fascia at south side of barn

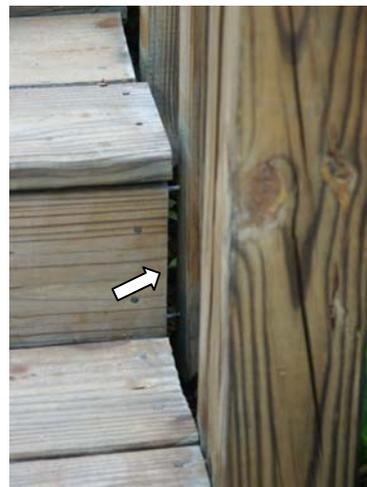
There are loose rails / ballisters at the rear decks that should be repaired.

Loose balusters at rear deck rail.

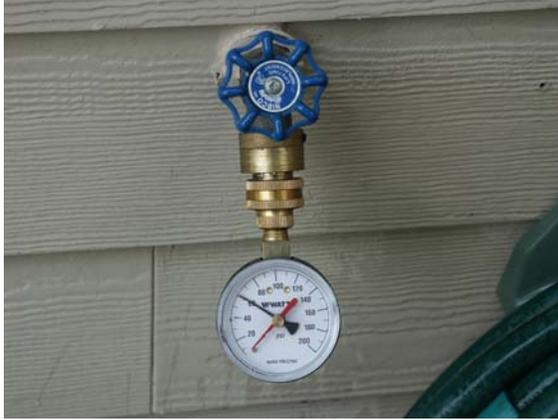
61 PSI Water Pressure at Ext. Spigot

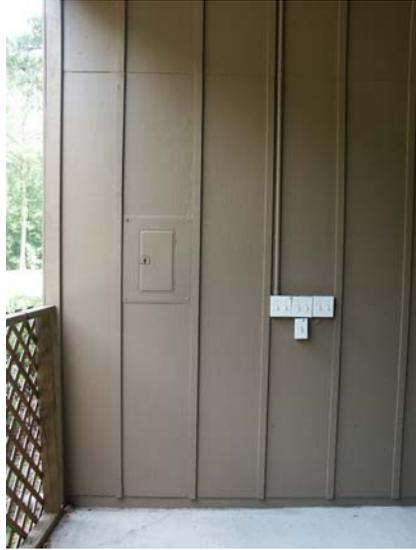
Electric subpanel at barn

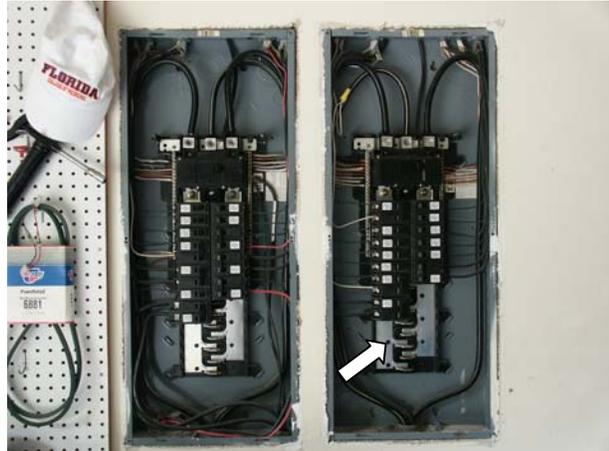
Interior of 150 amp panels in Garage.  
Note room for expansion at bottom of panel

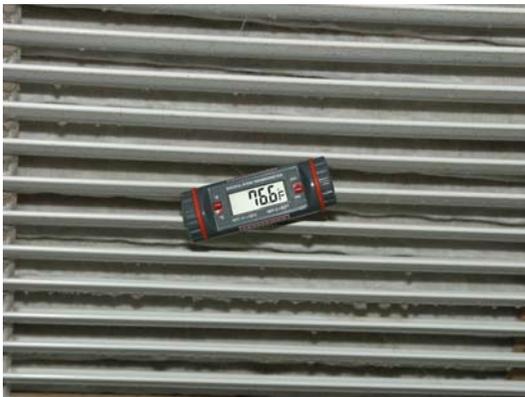
The proper temperature split between supply and intake air in an air conditioner is 14 to 20°F. Ambient air was measured with the Heat Pump in the cool mode to determine if the system was operating as intended. The supply air registered 61.1 degrees and the return air temperature was 76.6 degrees. This temperature differential indicates the system operating within a normal range.

Return air at 76.6 Degrees

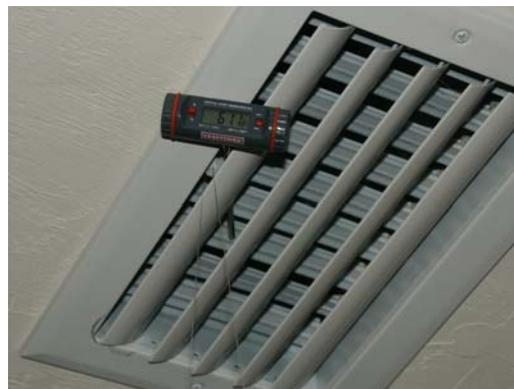
Supply air at 61.1 Degrees

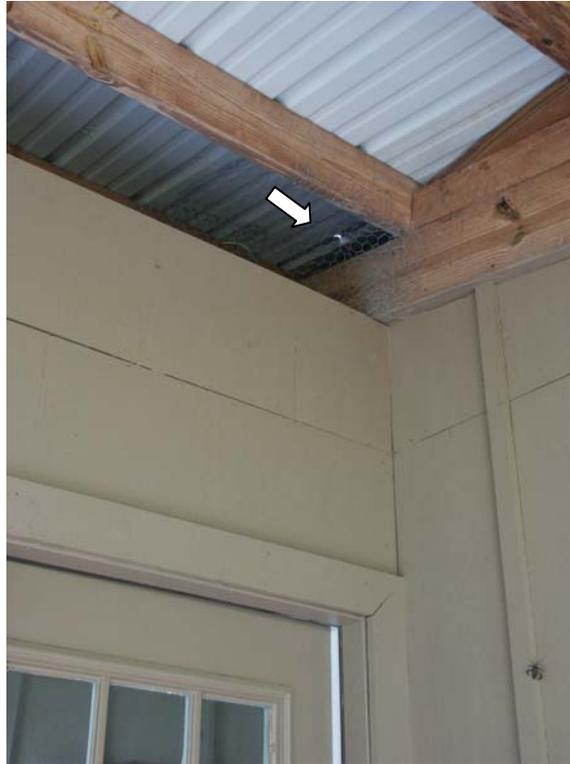
A small hole/leak was observed in the roof material above the barn/apartment entry.  
(see photo on pg.26)

Hole in metal roof at barn

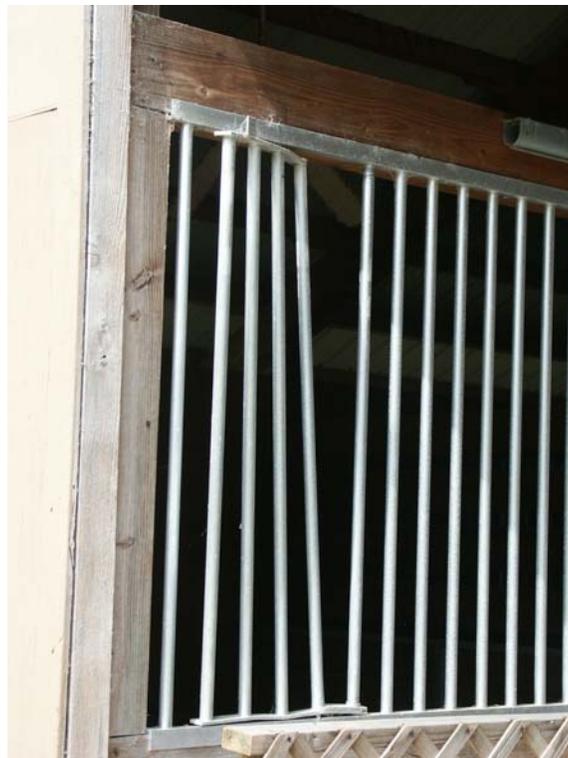
There is an area of damaged stall grate. See photo pg. 22

Damaged stall grates at barn
